Original Research Article

# Wearout evaluation of mechanic parts with multimaterial 3D printing

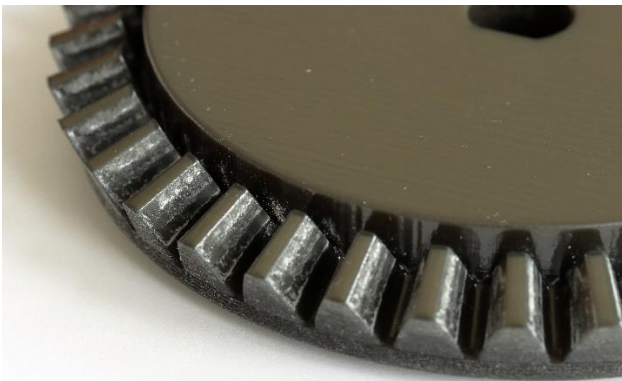
Figure 2: The contact pattern on the gear in drive direction shows an evenly distributed wearout along the upper half of the teeth.

After the test run, there were wearout marks visible on both, the pinion and the gear. There is no damage to the teeth of either wheels and the mounting holes for the driveshafts are undamaged. A closer look at the contact pattern [4] on the gear reveals a tip contact, where the upper part of the teeth shows an evenly distributed wearout across the radius in drive direction (see Figure 2).

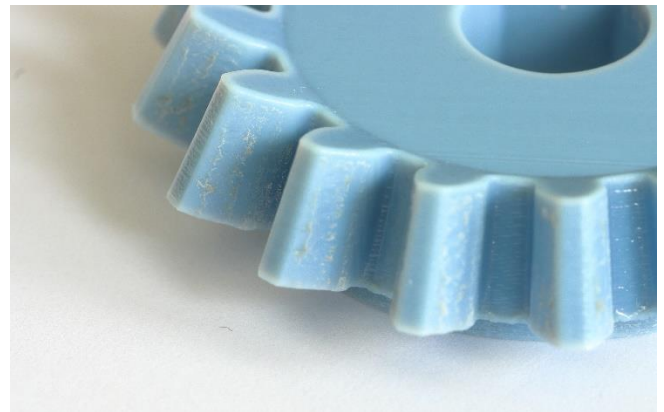
Figure 4: Wearout marks on the pinion in drive direction show only light rub-on of material from the gear, but no signs of abrasion.

On the pinion, wearout was less distinct. On the drive side of the teeth there is light rub-on of material from the gear with an inclined contact (see Figure 4) which can be seen on some of these teeth, possibly due to heating effects at the high speeds of the driving wheel.
